# OBSTRUCTION OF ENDOTRACHEAL TUBE; A MANUFACTURING ERROR

## - Case Report -

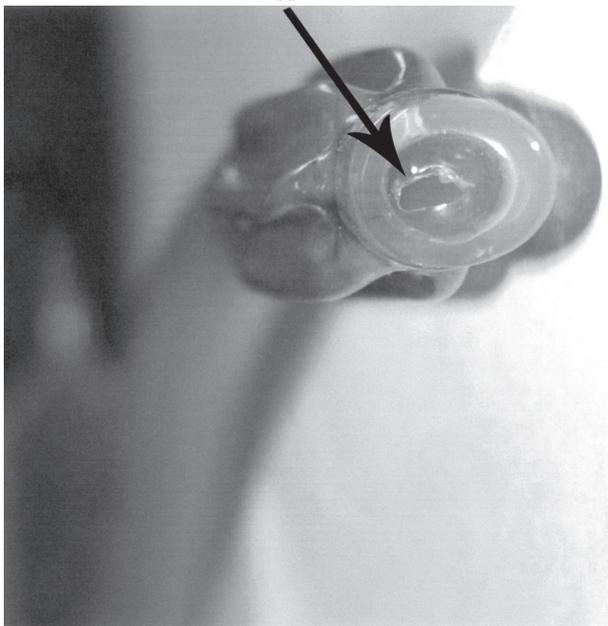
*Fig. 1*

Examination of the former tube revealed that there was as a manufacturing error (Fig. 1) consisting of a plastic film covering the distal opening of the tube with a small perforation (approximately 2.5 mm in diameter) at its mid-upper point. The subsequent anesthetic course was uneventful.

*Plastic film at the distal end of the ETT that was removed from the patient. Arrow shows the orifice in the plastic film with diameter of approximate 2.5 mm*

As this case demonstrates, the intrinsic occlusion of the ETT itself should be considered. Increasing airway peak pressure on a volume control mode of ventilation and persistently high ET $\text{CO}_2$  due to hypoventilation were the only early warning signs. The suction catheter was unable to pass through the tube due to the distal end block as the tube was occluded with a plastic film.

In conclusion, inspection of ETT prior to use is still the most crucial factor in confirming tube function. Vigilant monitoring of ventilator pressure and end tidal  $\text{CO}_2$  is the key to the early detection of airway obstruction. When airway obstruction is encountered in an intubated patient, it is important to consider both mechanical and pathologic factors. In cases where no other cause for inadequate ventilation is found, it is imperative to replace the ETT.
